# INSPECTION REPORT

4706 Hockaday Place, Columbia, MO March 30, 2017

Report No. 1316, v.0

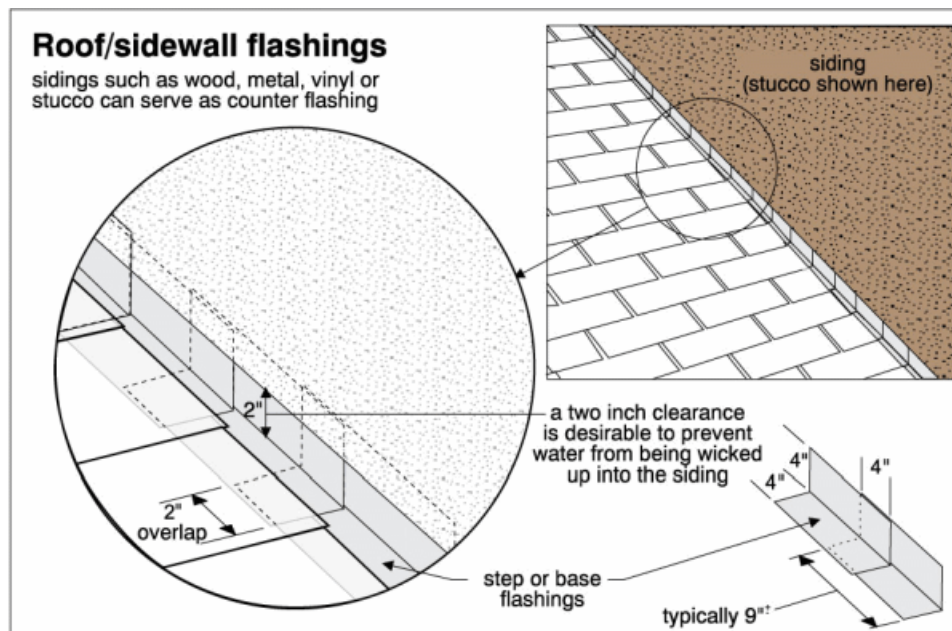
1. Condition: • [Too short or narrow](#)

Implication(s): Chance of water damage to contents, finishes and/or structure

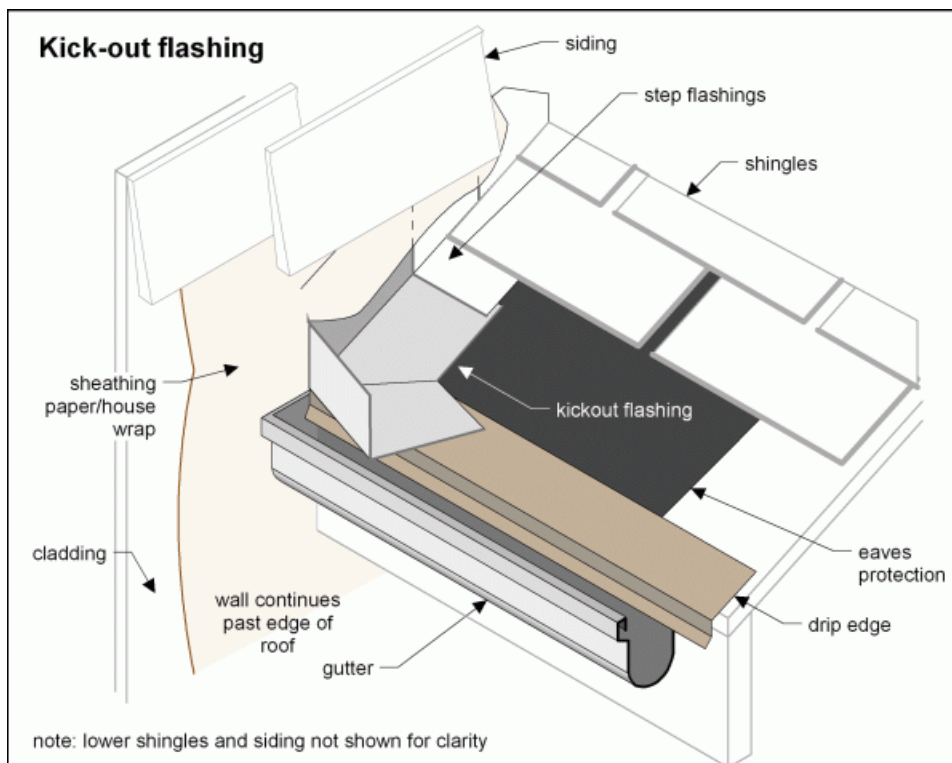
## 2. Condition: • [No kickout flashing](#)

**Implication(s):** Chance of water damage to contents, finishes and/or structure

**Task:** Provide kick out flashing

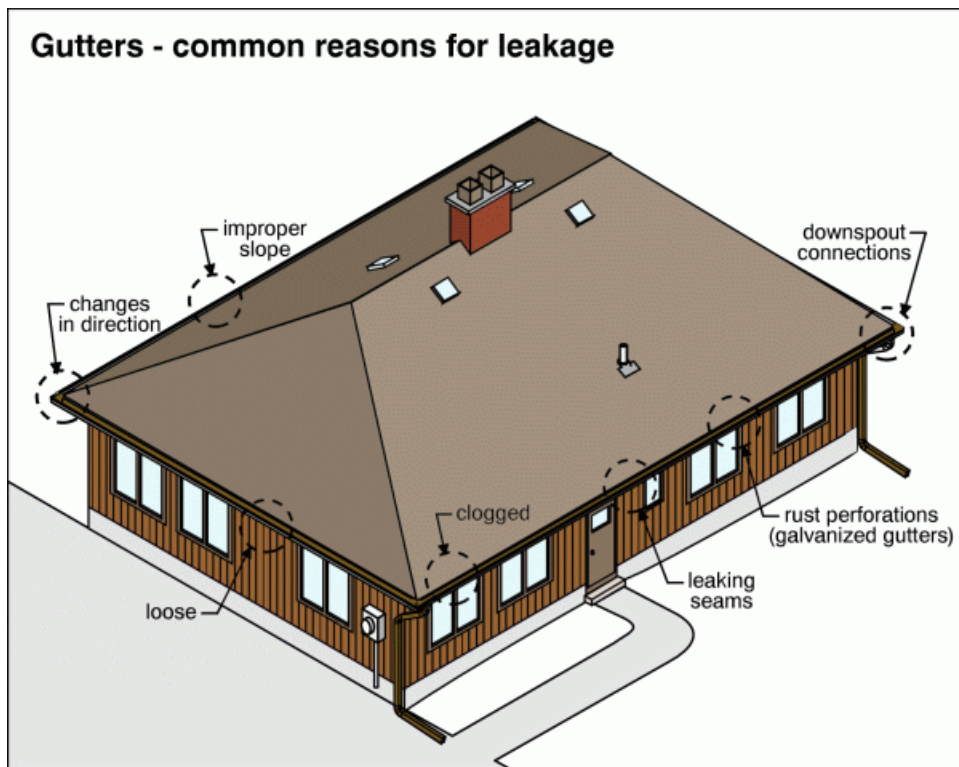
3. Condition: • [Leak](#)

Implication(s): Chance of water damage to contents, finishes and/or structure

Task: Repair

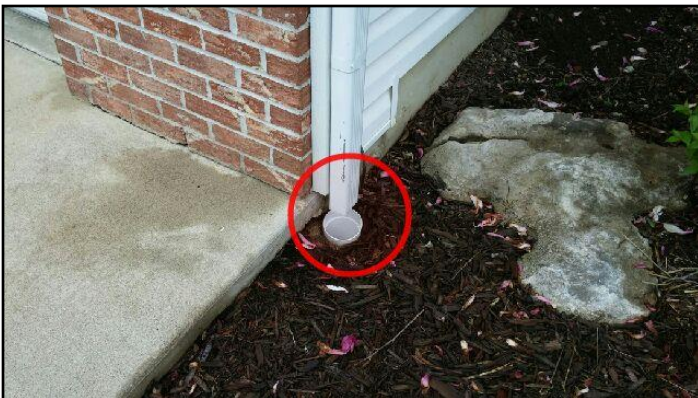
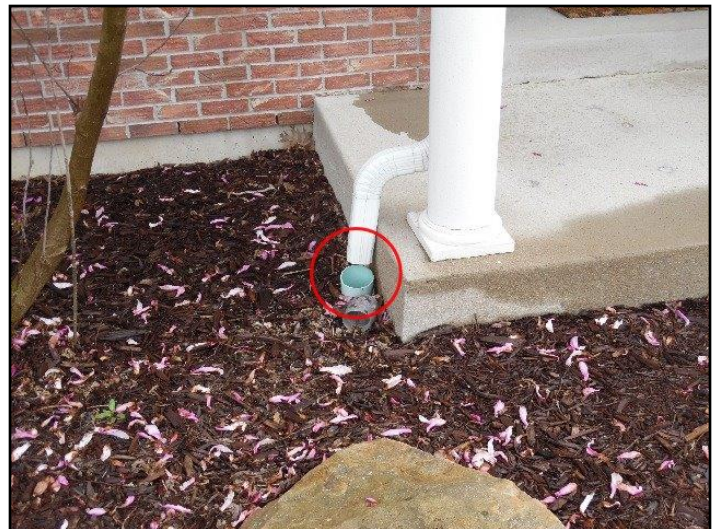
### 4. Condition: • Downspout out of position.

Implication: The downspout is not position over the underground pipe which would drop some of the roof water next to the foundation.

Task: Maintenance repairs are needed to restore the function of the downspout and thereby preventing possible wet basement problems and foundation settling. You should correct this immediately.

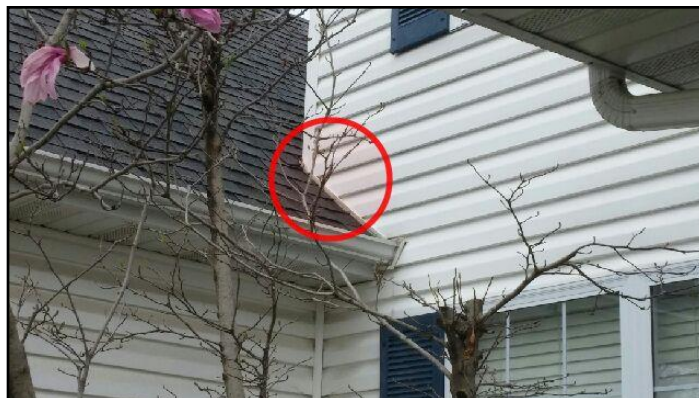
### 6. Condition: • [J-Channel lacks a half inch clearance to roof line.](#)

Implication: When the J-Channel is directly on the roof line, it can build up an excessive amount of heat. This heat may cause the J-Channel to expand excessively which can cause deformity on the J-Channel and can cause the horizontal siding to buckle.

Task: You could ask a siding contractor to make the repairs now or monitor this area of concern and make repairs on your next re-roofing job if needed. Click on the hyperlink above and go to page 26 of the vinyl installation manual.

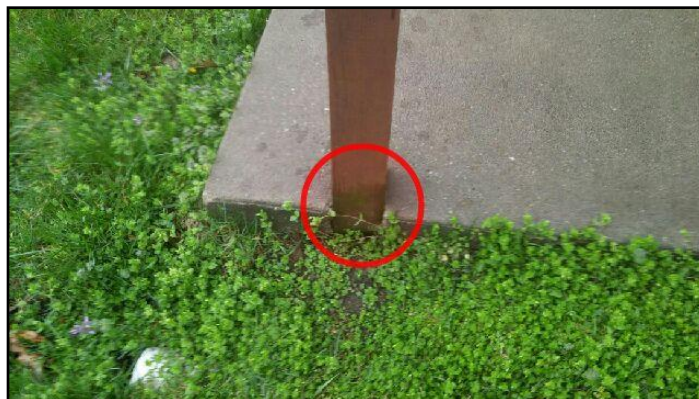
### **9. Condition:** • The support posts for the wood deck are buried inside the concrete footings.

Implication: In my opinion, this is a poor practice because as the wood shrinks, gaps are created between the sides of the posts and the concrete which could allow water infiltration. Water trapped within the footings may be subjected to frost heave causing the footings to crack. The bottom of the wood posts may decay as well.

Task: I advise that you hire a carpenter to re-install the posts on metal post brackets that are anchored to the footings.

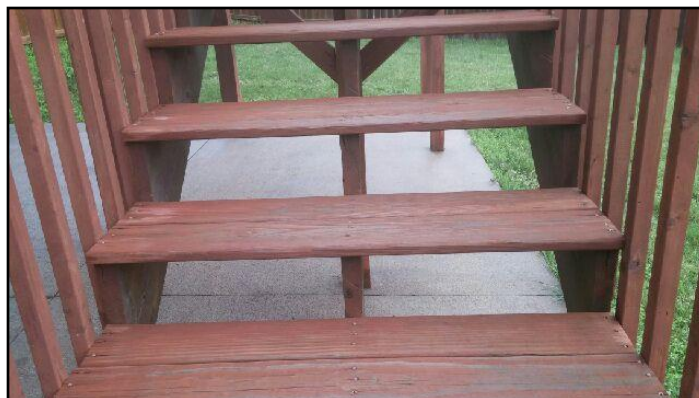
### 13. Condition: • A staircase has open risers.

**Implication:** SAFETY WARNING - Be advised that open risers can cause a tripping accident and personal injury.

**Task:** I advise that you hire a carpenter to close the risers or alter the staircase as needed to improve its safety.

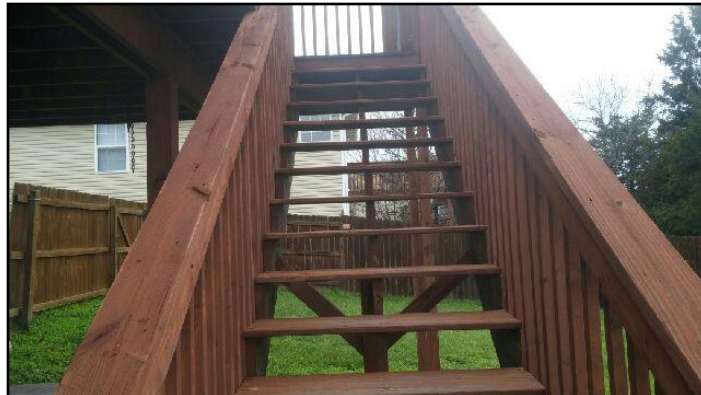
**15. Condition:** • A grip-able handrail is missing at deck steps.

**Implication:** Without a grip-able hand rail on the steps to grip to when there is ice, snow or wet could cause personal injury form a fall.

**Task:** I recommend that this be installed for personal safety.

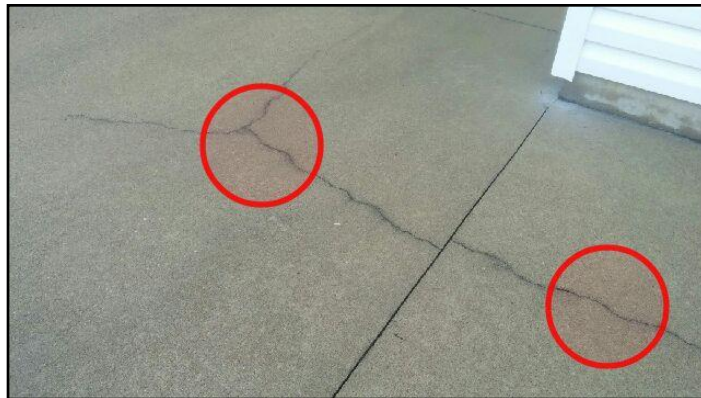
**19. Condition:** • Small hairline cracks.

Implication: Rain water that seeps into these cracks could cause settling, heaving and cracking in the winter due to water expanding which causes cracks on the concrete pour.

Task: I advise the application of crack filling or other suitable product be used to seal these cracks.

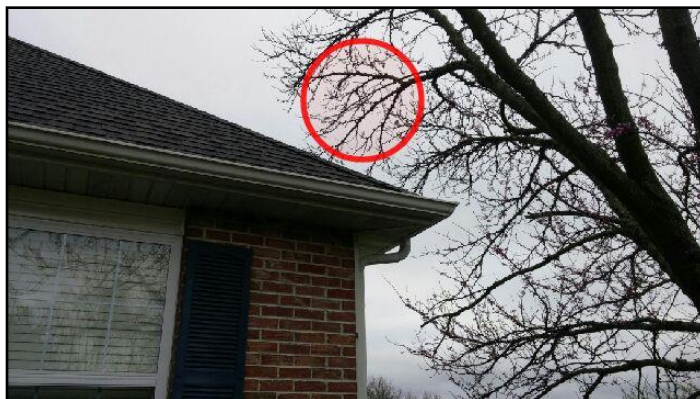
**22. Condition:** • Tree branches overhang over roof

Implication: Damage to roof and building.

Task: Trim branches away from the house and roof.

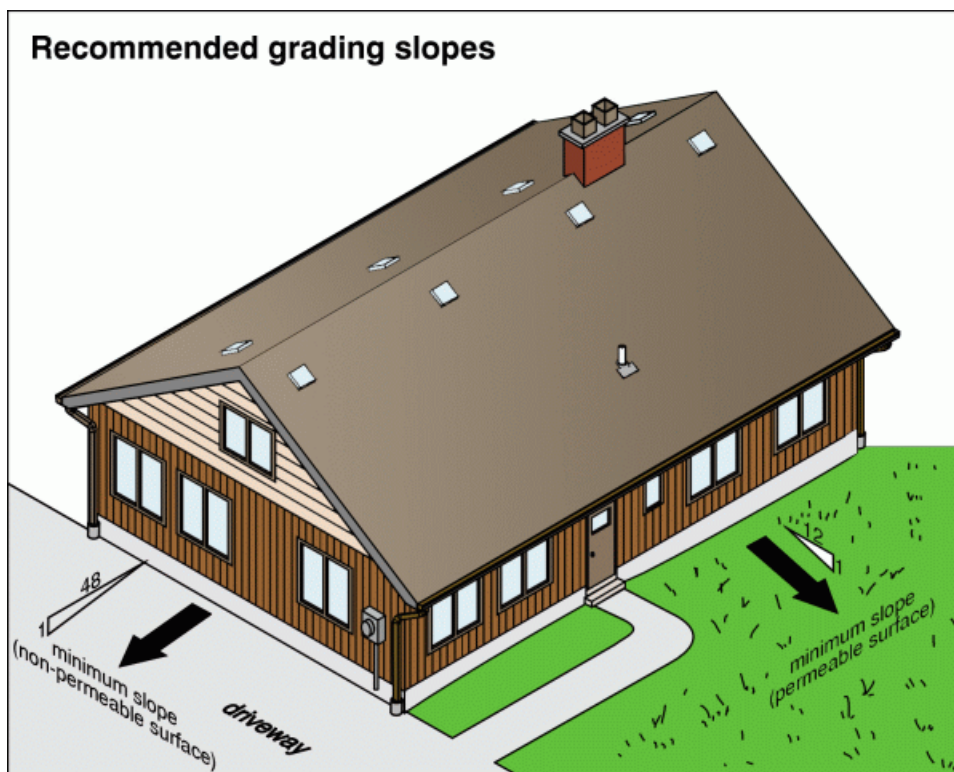
23. Condition: • [Improper slope or drainage](#)

Implication(s): Chance of water damage to contents, finishes and/or structure

Task: Correct

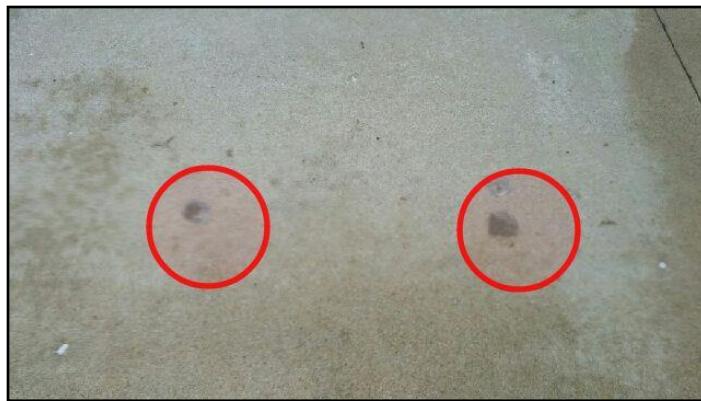
**24. Condition:** • It appears that the driveway has had some repairs done in the past

**Implication(s):** the driveway may have settled in the past and there is some repairs that were made.

**Task:** inquire who did the repairs and if there is a warranty that can be transferred.

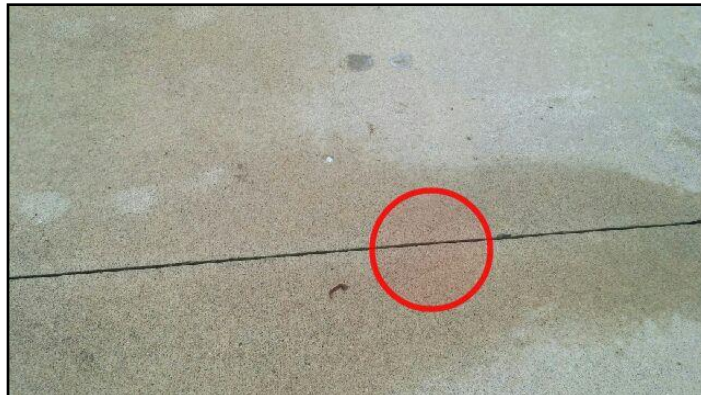
**25. Condition:** • Expansion joints not sealed.

**Implication:** Water will infiltrate the expansion joints and cause cracks due to expansion of the water inside the control joints.

**Task:** Caulk is advised.

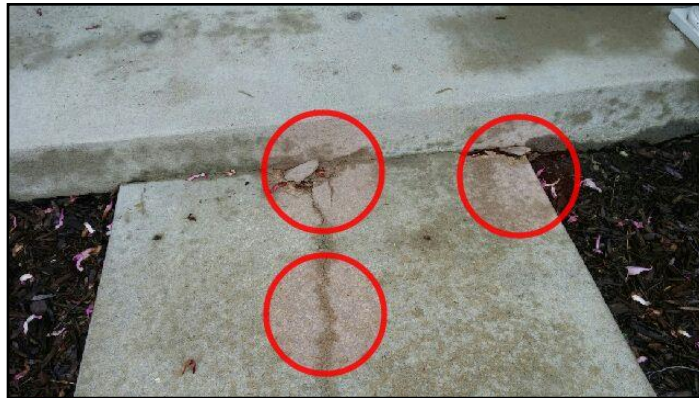
**27. Condition:** • [Cracked or damaged surfaces](#)

Implication(s): Trip or fall hazard

Task: Repair

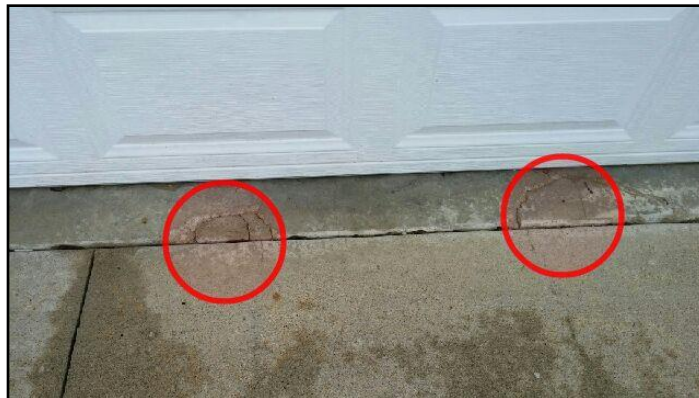
**28. Condition:** • Fracture noted on edge of garage floor.

Implication: This type of fracture on edges of garage floor is common but if not repaired it could continue to fracture which can be very displeasing.

Task: We recommend that this area be sealed with a cement product to prevent further fracturing.

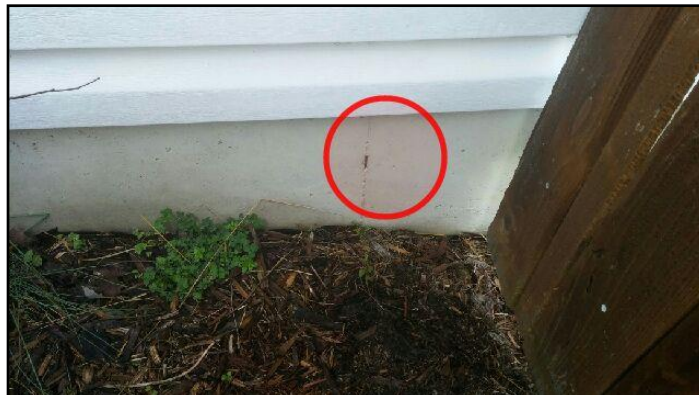
**29. Condition:** • Metal snap ties were not sealed.

Implication: While this condition in no way affects the function of the foundation, the exposed metal can rust thus causing hairline cracks which can allow water infiltration into the cracks and as this water or moisture expands in the winter it can expand the cracks as well. A rusted tie will also stain the wall.

Task: I recommend that all exposed snap ties be sealed to prevent any problems in the future. These can be sealed with hydraulic cement to retard water infiltration.

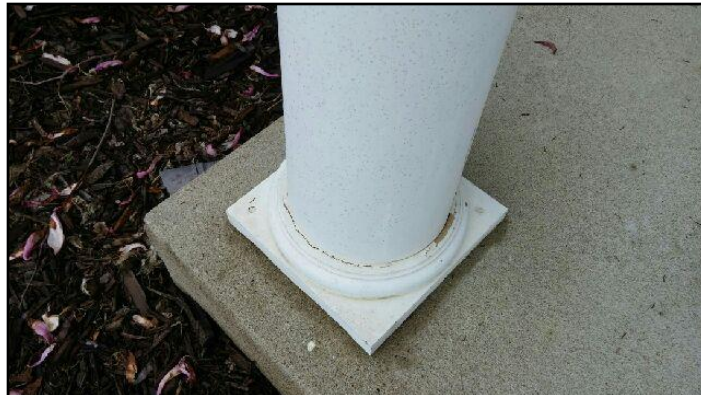
**31. Condition:** • Gaps visible.

**Implication(s):** Rain water entering this gaps can cause water or rot to the bottom of the columns.

**Task:** Seal or caulk these areas

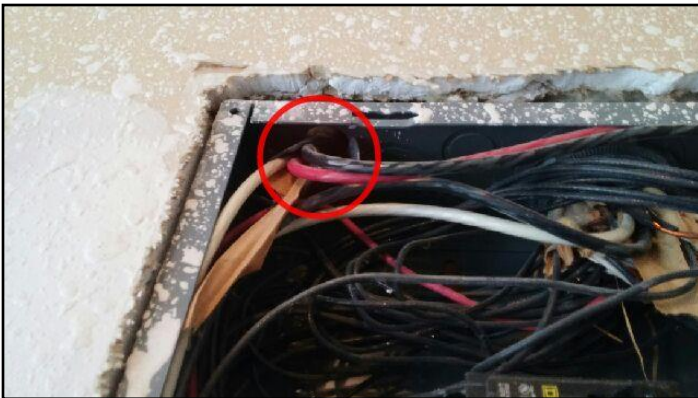
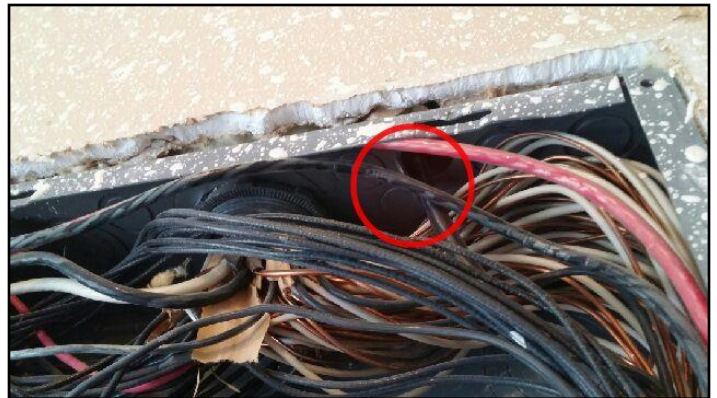
**33. Condition:** • Romex connectors missing.

Implication: WARNING - Romex connectors are required to secure the wires and to prevent chaffing against the sharp edges of the metal hole in the panel. Be advised that this omission could cause pose a fire or shock hazard.

Task: Hire an electrician to open the drywall beneath the main panel and to install the romex connectors where missing.

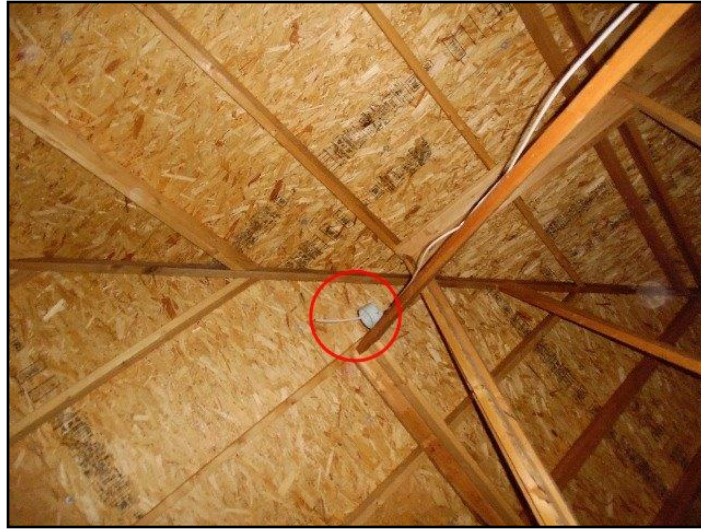
**34. Condition:** • [Inoperative](#)

**Implication(s):** Inadequate lighting

**Task:** Install this light fixture to provide light in the attic.

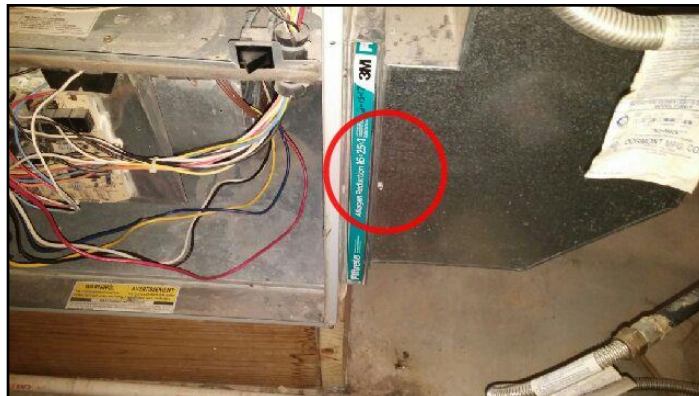
**38. Condition:** • The cover is missing for the air filter.

**Implication:** This should be installed due to the fact the dust could be getting inside the blower and motor units thus reducing the furnace efficiency.

**Task:** Install a cover over the air filter opening.

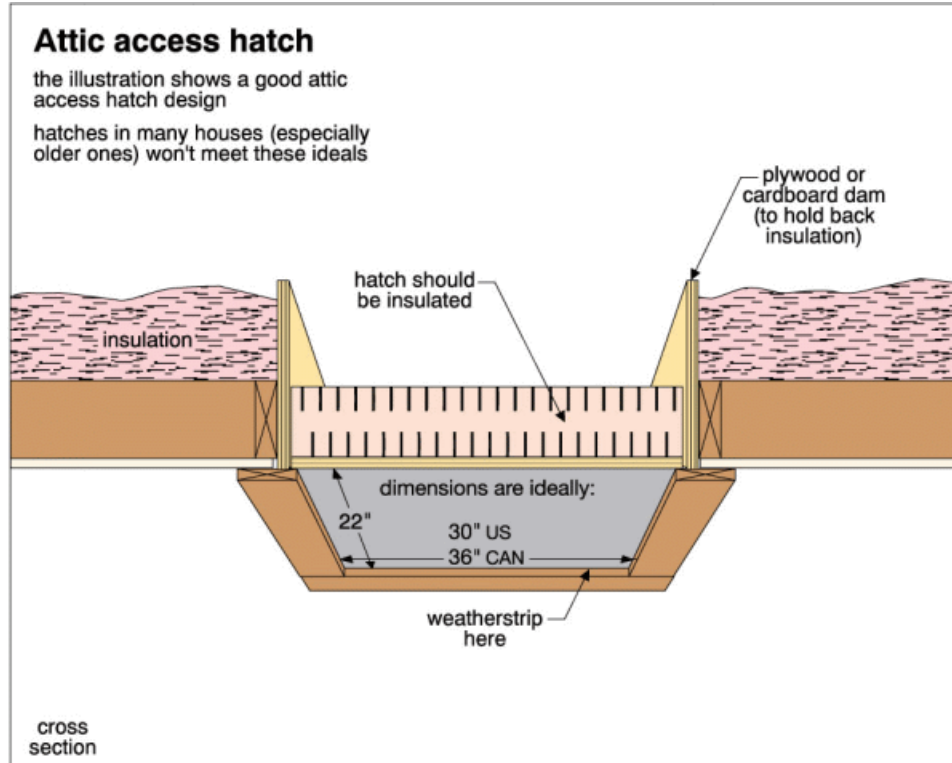
**41. Condition:** • [Not insulated and not weatherstripped](#)

**Implication(s):** Chance of condensation damage to finishes and/or structure | Increased heating and cooling costs | Reduced comfort

**Task:** Provide

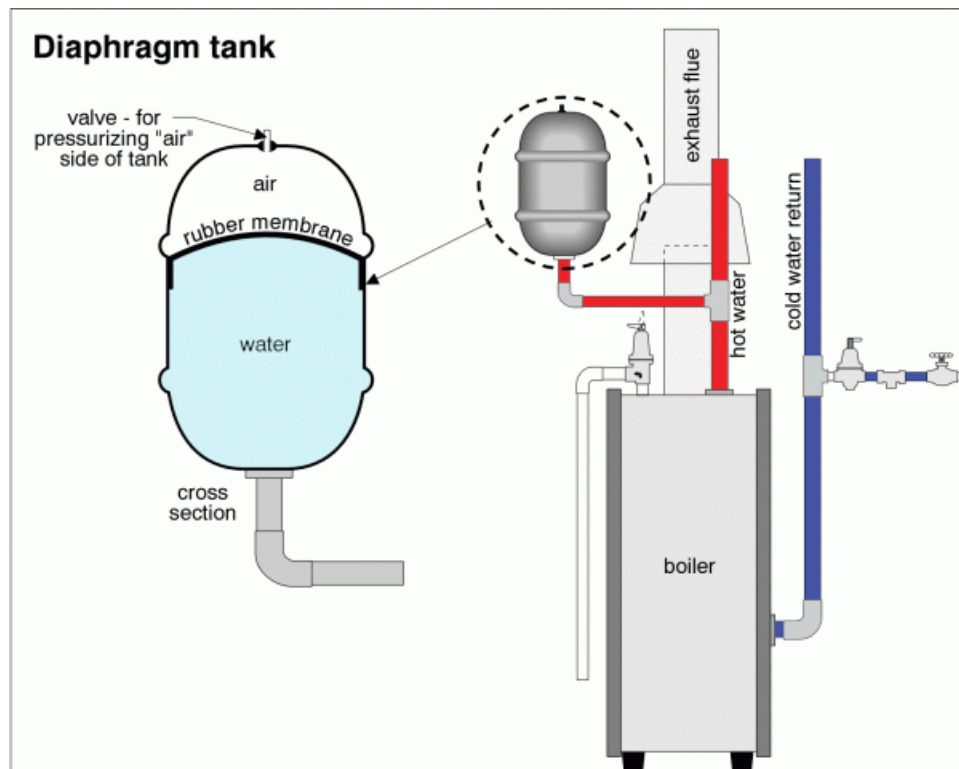
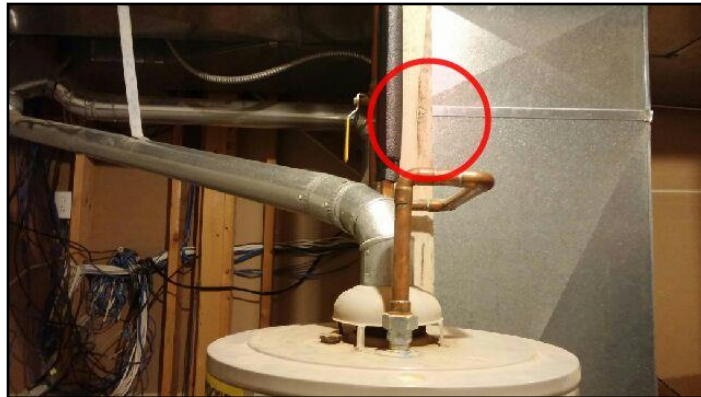
**43. Condition:** • Virtually every modern plumbing code requires the installation of an expansion tank on water heater installations whether gas or electric. The reason is simple. Water expands when heated. This extra volume of water needs to go somewhere. Before the widespread usage of backflow preventers, check valves and pressure reducing valves, this expanded water simply pushed the cold water back into the city water main, and since you have one or more of these devices you could have problems. These devices prohibit the flow of water from your house back into the public water system.

Without an expansion tank, the expanding water can cause your water heater to possibly fail because of the increased pressure. This pressure can cause serious life threatening problems as well, if you heat your water with natural gas or propane. The water heater tank can collapse around the internal flue and cause carbon monoxide to enter your home. It is serious business.

Recommendation: When this water heater was installed years ago it was not a requirement but now it is. Therefore we recommend that you install an expansion tank on this unit the next time you hire a plumber to do any other work to this house.

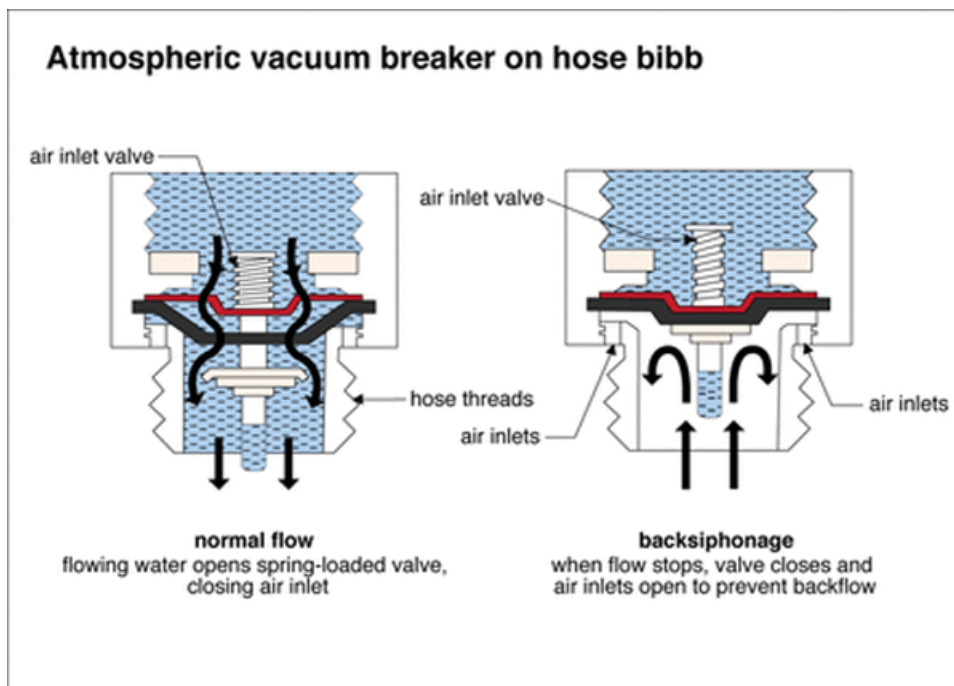
**45. Condition:** • The exterior hose bib is not an anti-siphon type bib.

**Implication:** Anti-siphon device serves to prevent chemicals from getting into the house water supply when mixing chemicals for exterior landscaping.

**Task:** It is recommended that an anti-siphon device be added to the hose bib(s) either now or when you have a plumber do any other work around the house.

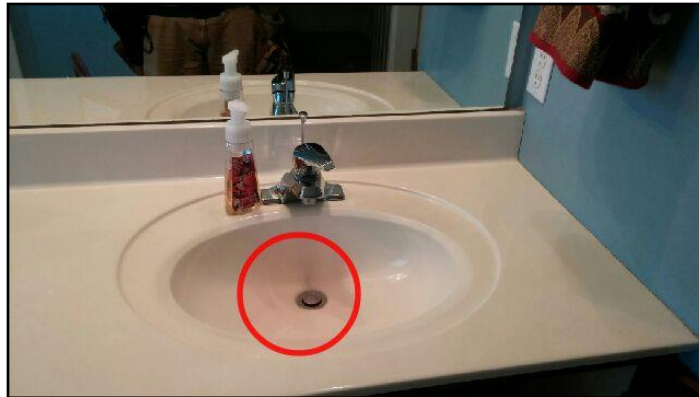
**48. Condition:** • Drain stop ineffective

**Task:** Improve

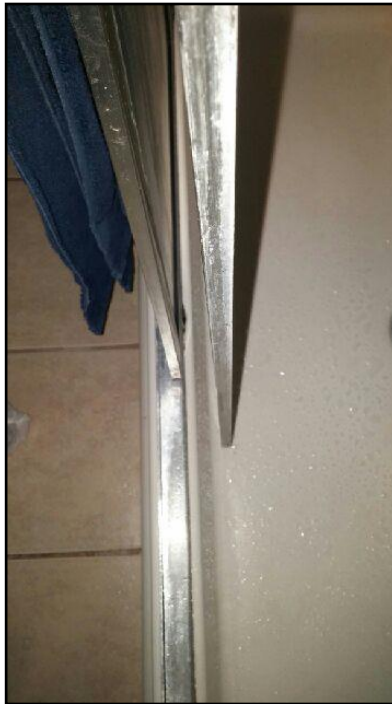
**54. Condition:** • keeps the doors place.

**Task:** Repair or replace

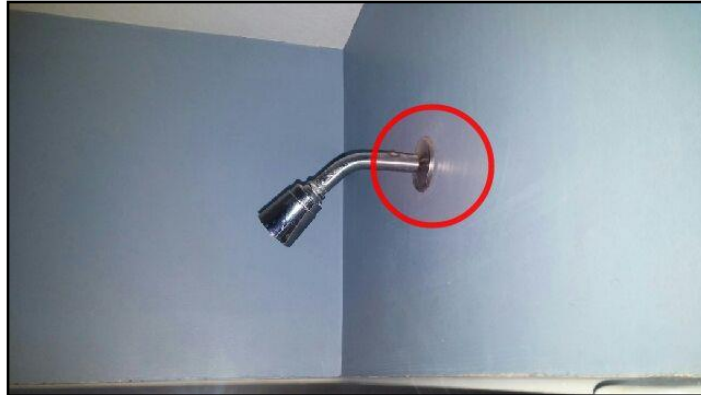
**55. Condition:** • The protective flange, known as an escutcheon, is not properly sealed or caulk at the shower stall assembly.

**Implication:** If allowed to remain as is, this could allow water to enter the wall and cause hidden decay.

**Task:** I advise that the flange be caulked. This is a simple maintenance repair.

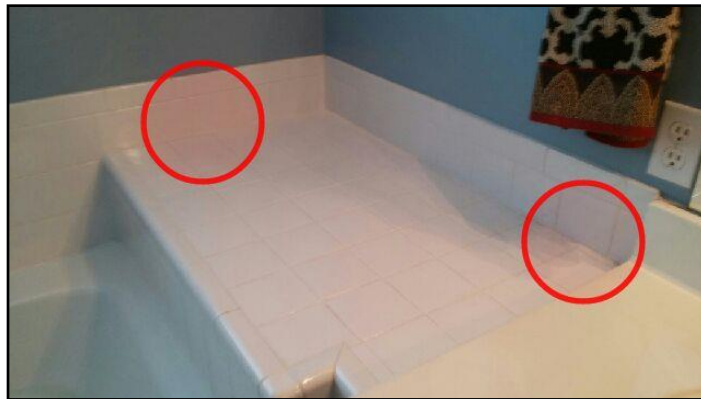
**56. Condition:** • Gaps noted on the tile wall.

**Task:** Seal or caulk this area

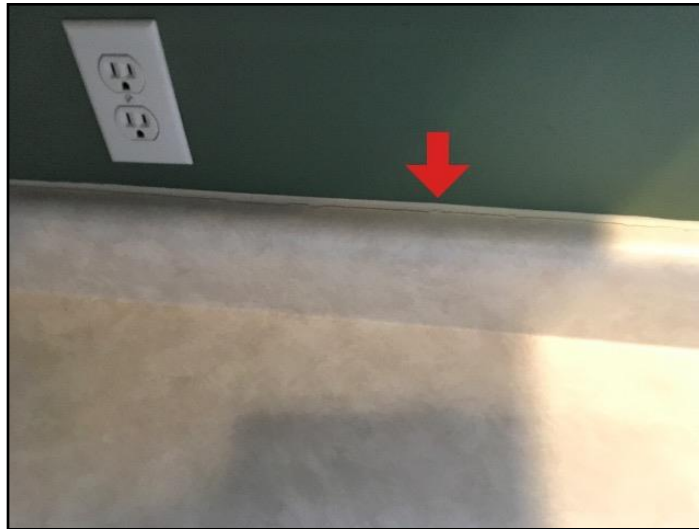
**61. Condition:** • Gaps on counter top.

Implication: Gaps on counter top and or back splash will allow the accumulation of dirt and will allow leakage when the counter is cleaned.

Task: Seal or caulk the gap as required.

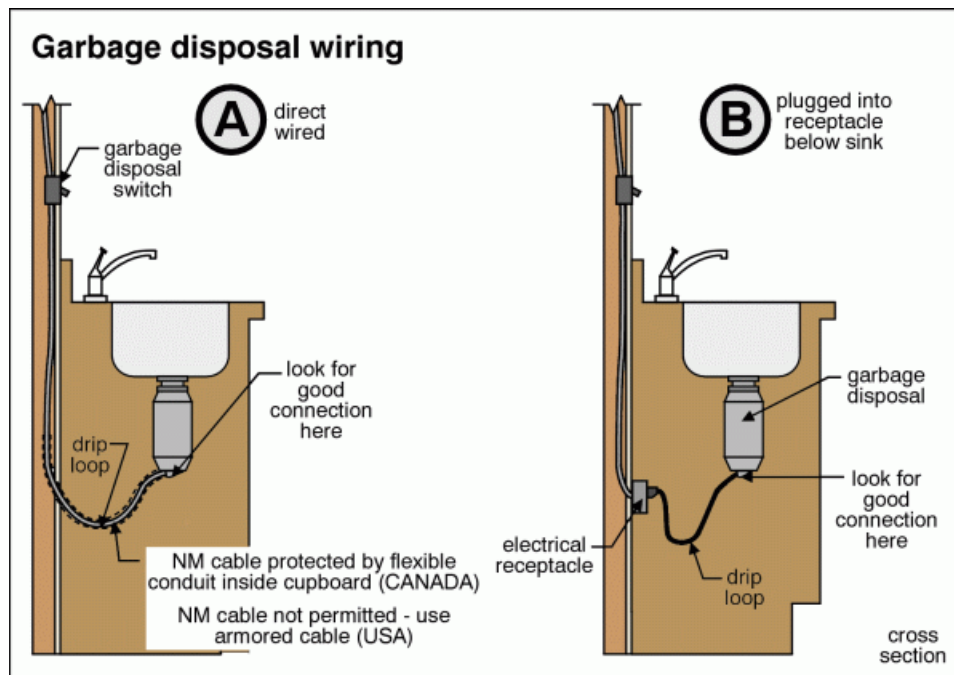
**69. Condition:** • The garbage disposer wiring is not equipped with a armor cable or BX cable.
