# INSPECTION REPORT

4706 Hockaday Place, Columbia, MO March 30, 2017

Report No. 1316, v.0

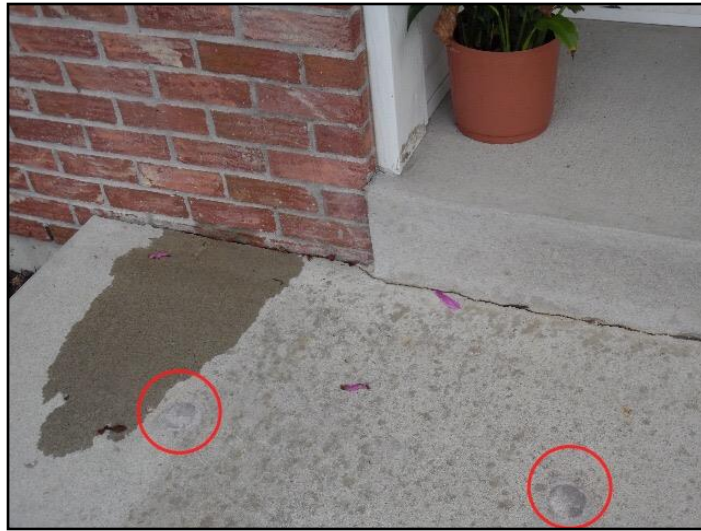
**19. Condition:** • Small hairline cracks.

Implication: Rain water that seeps into these cracks could cause settling, heaving and cracking in the winter due to water expanding which causes cracks on the concrete pour.

Task: I advise the application of crack filling or other suitable product be used to seal these cracks.

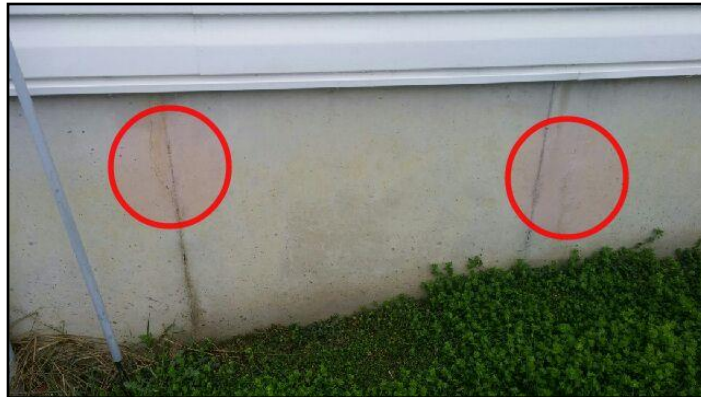
**31. Condition:** • Gaps visible.

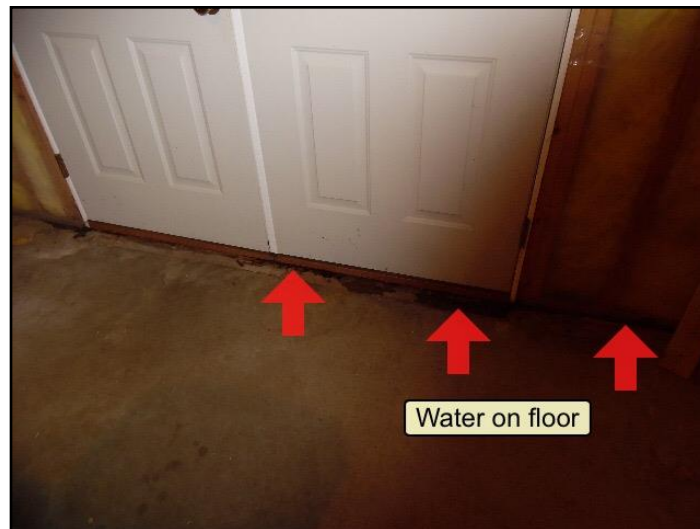
**64. Condition:** • Floor revealed thin hairline shrinkage type cracks.

Task: You can seal the cracks yourself with a hydraulic cement product or suitable caulk. Once repaired, the cracks should be monitored for unpredictable future movement.
